Engineering Failure Analysis

The Conclusion from One Million Tonnes of Experience in Galvanizing Steel – LMAC is not a Primary Instigator of Cracking

Keywords: Galvanizing; structural steelwork; cracking; industrial experience.

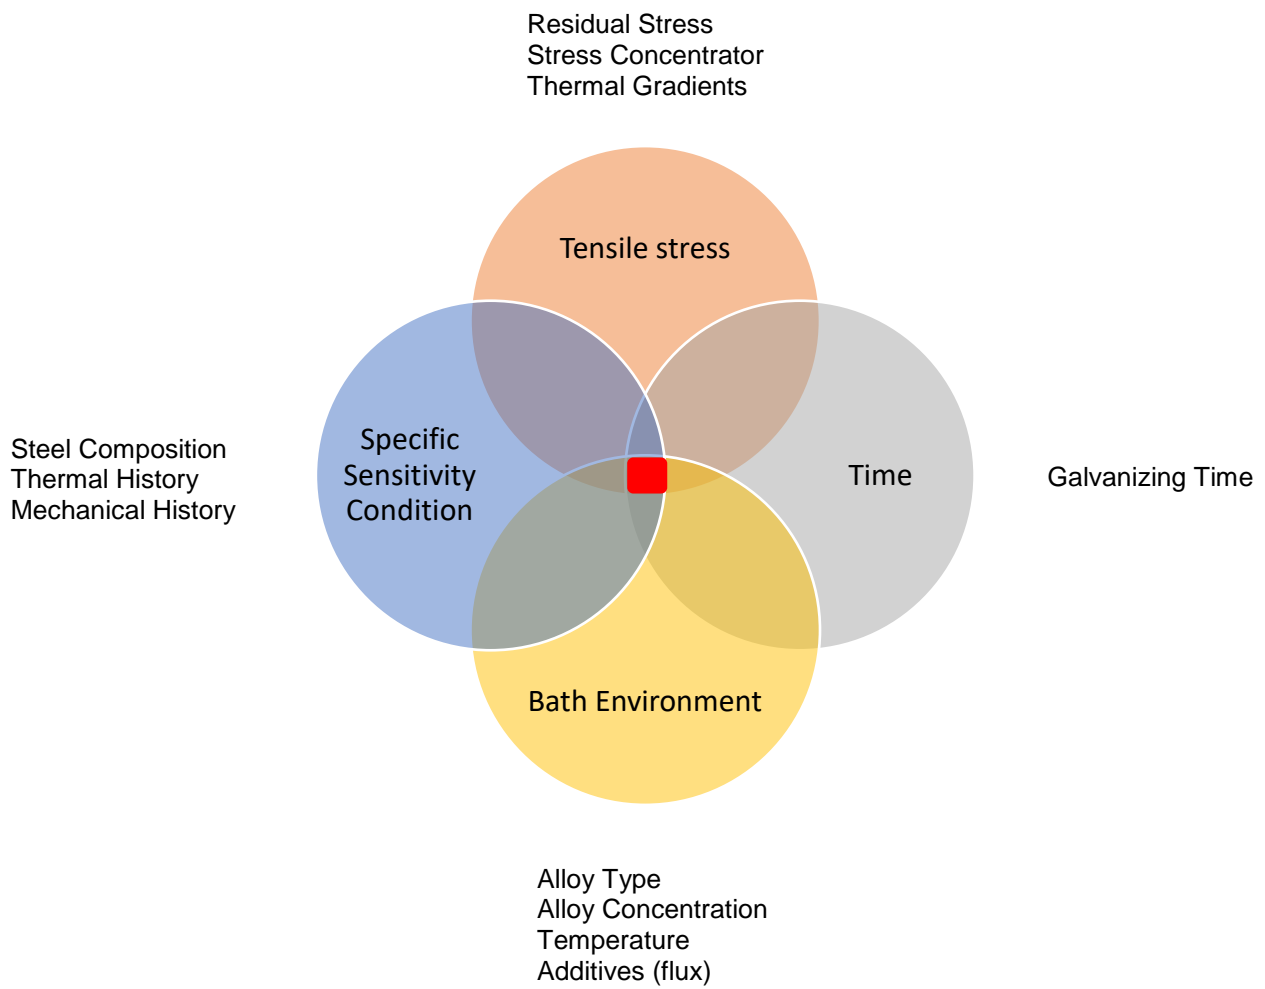
Figure 1 Venn diagram showing the critical intersection region (red) of the four necessary conditions defined by Kinstler [7] for the occurrence of LMAC during galvanizing.
